INVENTORY of POTENTIAL and EXISTING UPSTREAM RESERVOIR SITES

NASHUA STUDY AREA
Massachusetts

U.S. DEPARTMENT of AGRICULTURE
Soil Conservation Service
Economic Research Service
Forest Service

MARCH 1972

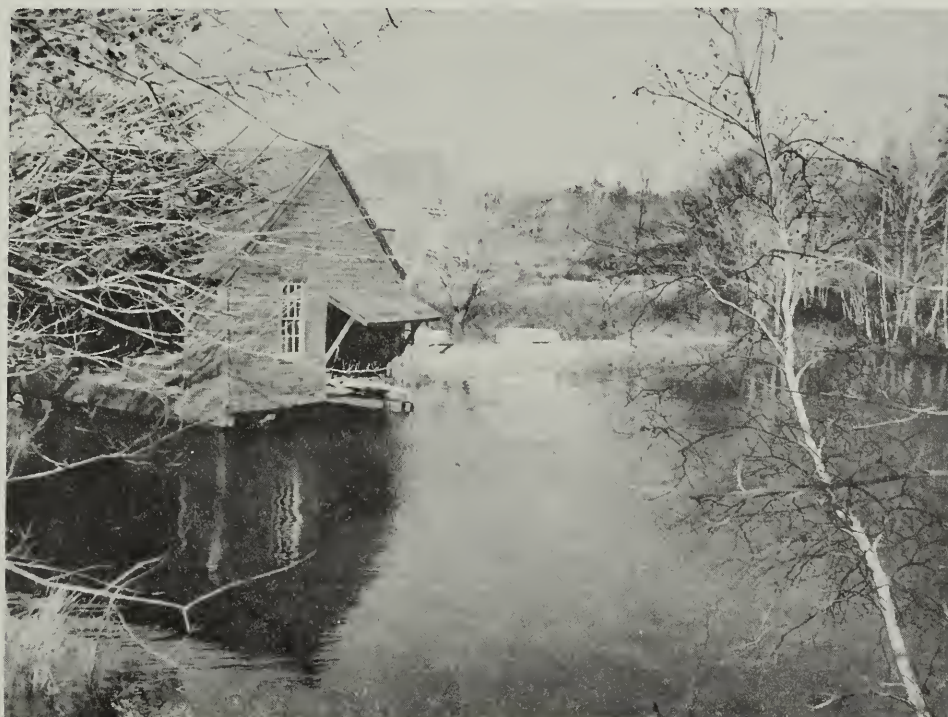
NA-0111 -- WARD POND

This is an old stone mill dam with a building over the structure. Stone work is in poor condition.

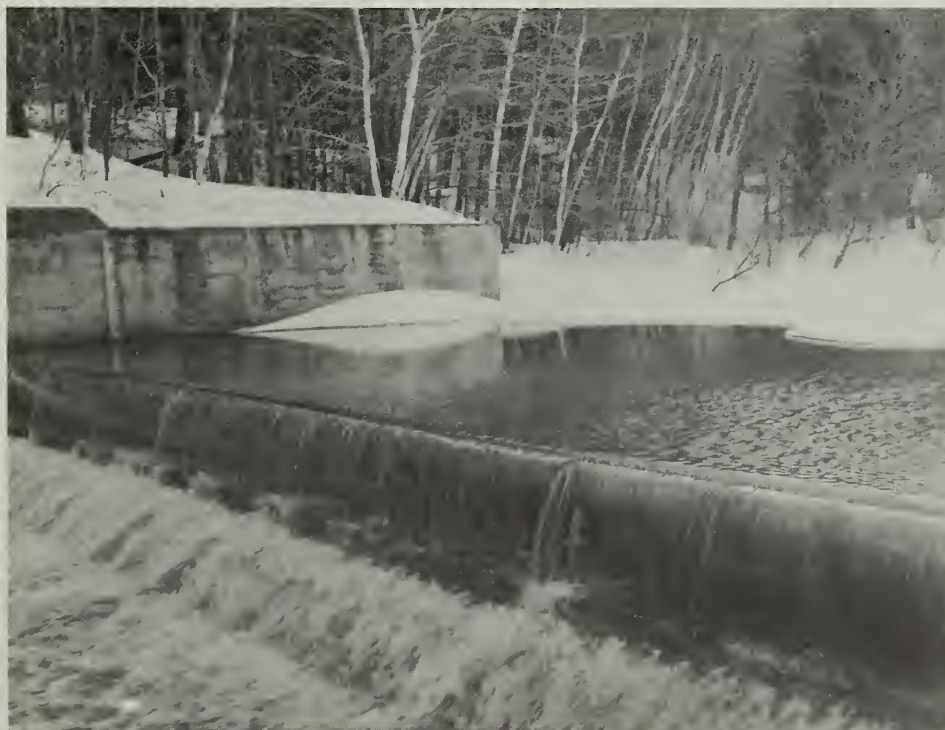
SITE NA-0228

Remarks: This is an earth dam with a modified concrete
chute spillway at the right abutment. Spillway
weir is about 40 feet wide with about 6 feet
of freeboard. There are trees on the downstream
slope of the dam, but the earthfill and spillway
appear to be in good condition.

Geologic
Conditions: The right abutment is outwash sand and gravel,
but may be shallow to schist bedrock. The
left abutment is thin englacial drift, silty
sand and gravel. There are schist bedrock
outcrops in the foundation. There is a
possible leakage problem in the right abutment.
Impervious borrow material for dam construction
possibly is available on the left abutment.
Waterholding capabilities appear good.

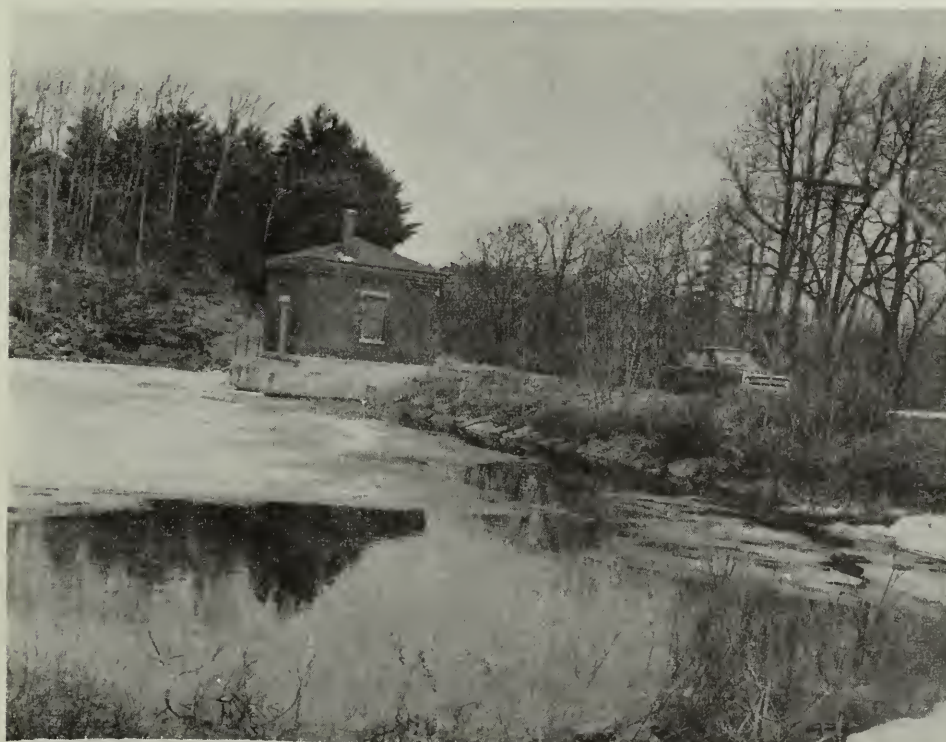
NA-0231 -- CROCKER POND

This reservoir is part of the Fitchburg Water Supply. The embankment of Princeton Road ties into the earth fill dam. Downstream face of Princeton Road fill is vertical with rock retaining wall. Upstream slope has been riprapped.

Dam abutments are rock ledge. Spillway is a concrete weir (30' wide) with flashboards. Total structure appears to be in good condition.

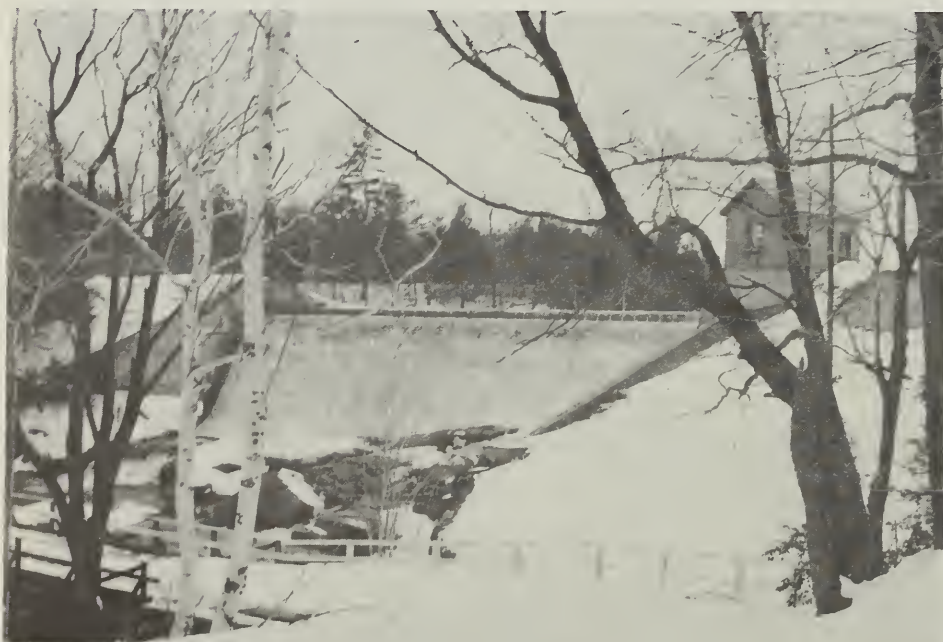
NA-0232 -- WACHUSETT LAKE

Both abutments are outwash sand or gravel. There are bedrock outcrops in the foundation. There are leakage problems in both abutments. Impervious borrow material for dam construction was not located on site. Waterholding capabilities appear poor above present water level.

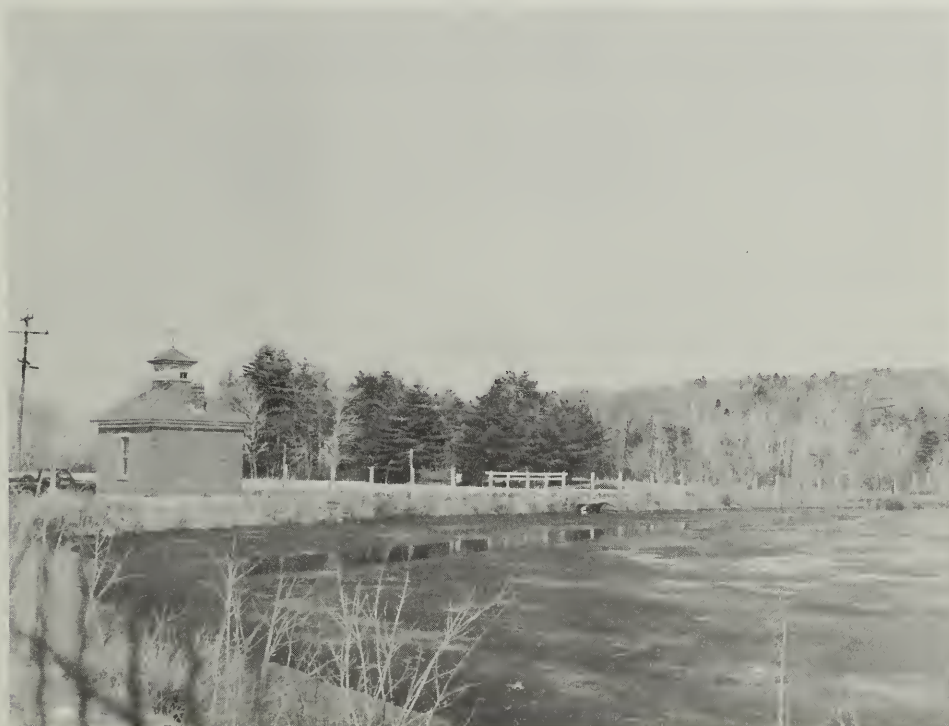
NA-0233 -- WINNEKEAG LAKE

Both abutments are sand and gravel, glacial
outwash. Depth to schist bedrock in founda-
tion not known, but may be 40 to 50 feet.
There are leakage problems in both abutments.
Imprevious borrow material for dam construc-
tion was not located on site. Waterholding
capabilities appear to be poor above present
water level.

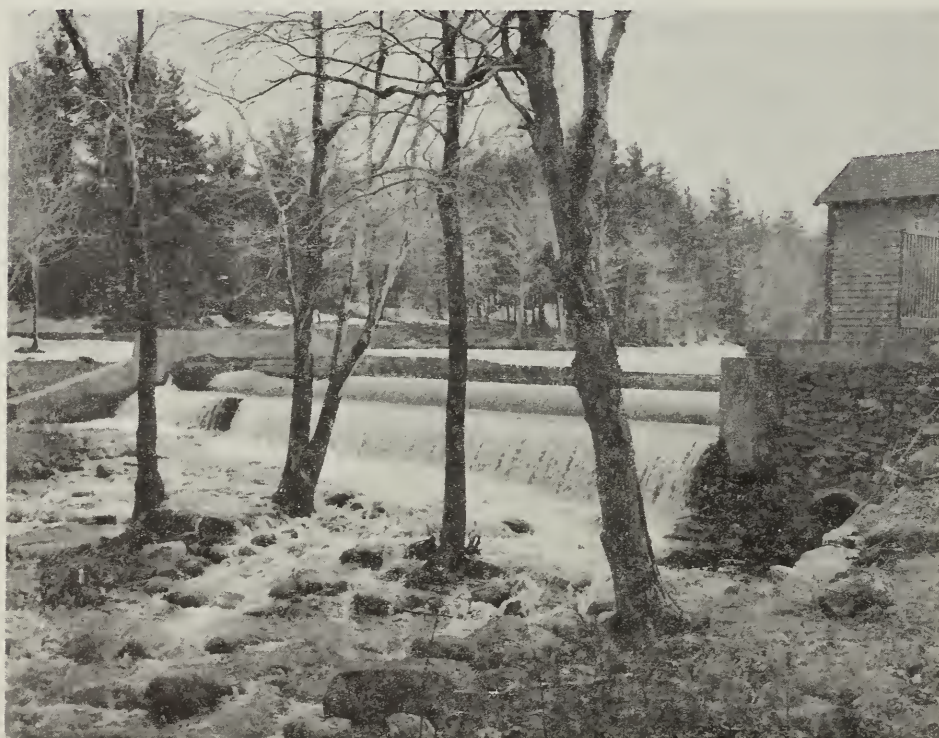
NA-0236 - PARTRIDGE POND (Ellis Pond)

This is a low earthfill dam with a 50 foot wide concrete weir spillway. Upstream face of dam is rock riprapped. There is some concrete spalling near the waterline at the weir sidewalls. Dam appears to be in good condition.

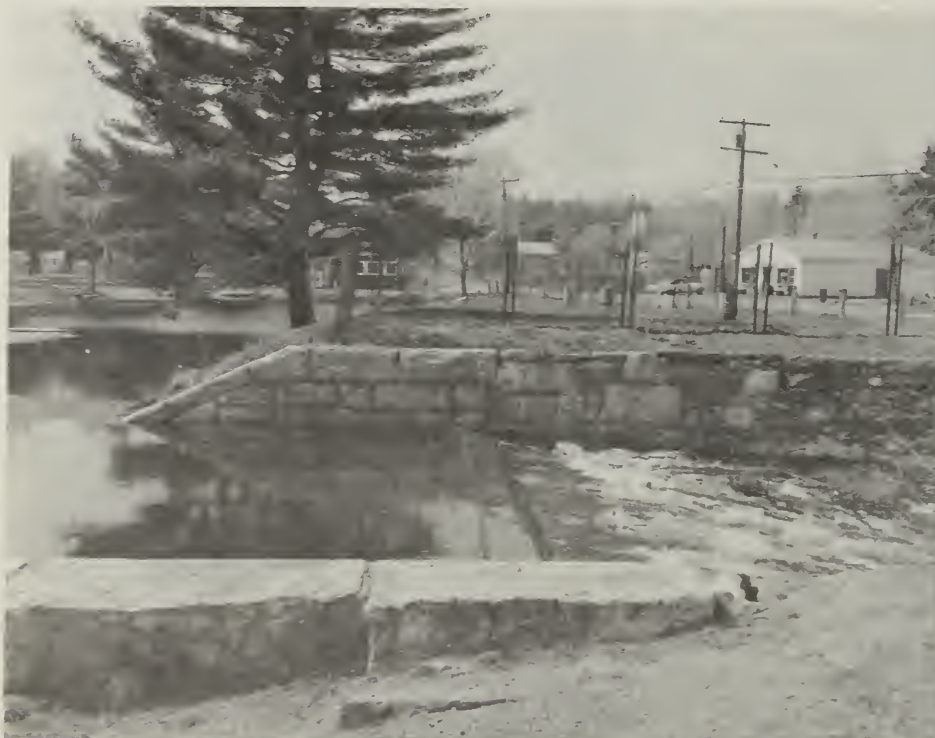
NA-0238 -- SNOWS MILL POND

This pond is a part of the Fitchburg Water Supply. Structure is an earth dam built in the late 1800's. Upstream slope of the dam is riprapped. Spillway has a 50 foot weir leading to a masonry chute spillway. Dam and spillway are in good condition.

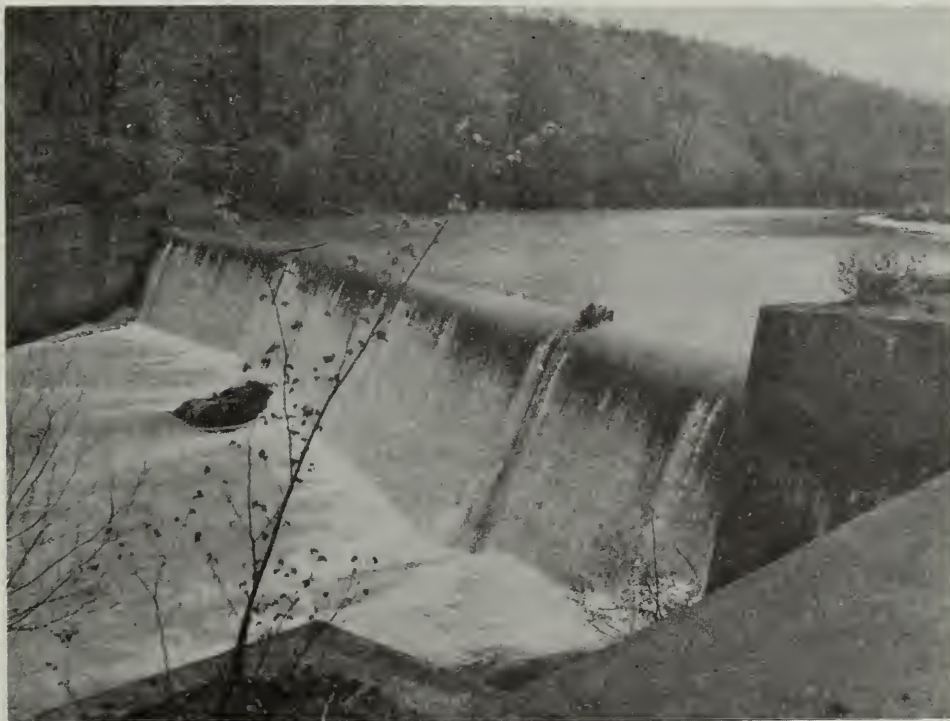
NA-0239 -- SAWMILL POND

This is a mill pond with various intake
structures to use the water. The main
spillway has an overflow weir about 100 feet
long. Structure appears in good condition.

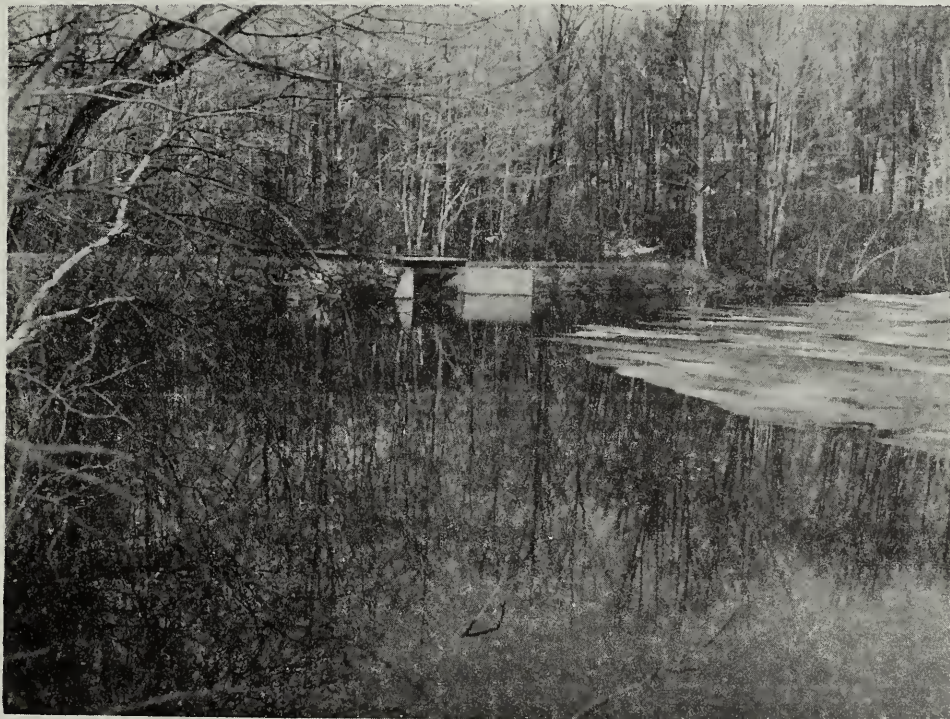
NA-0241 -- CROCKER POND

Remarks: This is an earthfill dam. Upstream face is
riprapped. Spillway is a concrete drop
structure with a 10 foot weir and 3 foot
drop. Condition is good except for small
trees and brush growing on slopes.

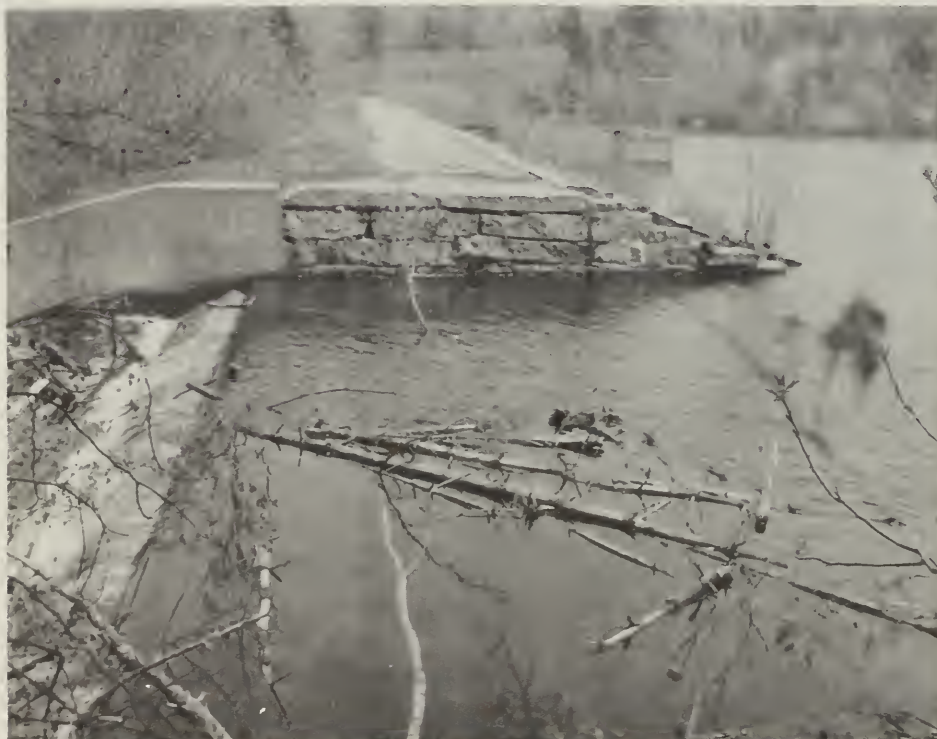
SITE NA-0318

This is a long earth dam. Upstream slope
has rock riprap. Spillway at left abutment
is about 4 feet deep by 50 feet wide.
The structure is in good condition, but has
some trees and brush along waterline.

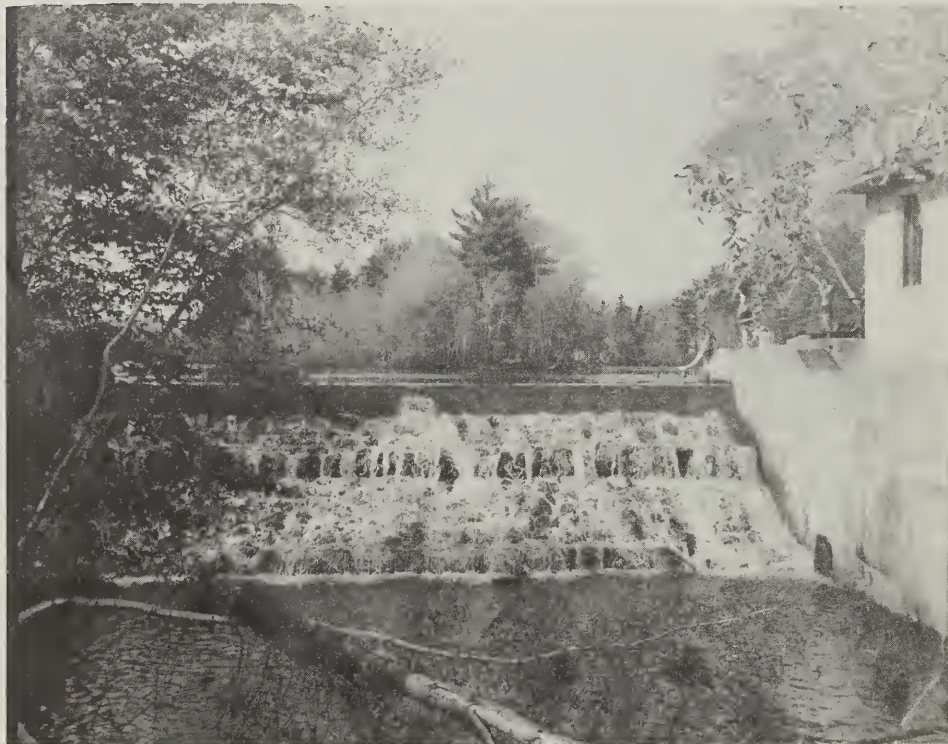
NA-0320 -- ROCKWELL POND

This is an earth dam. Spillway is a 50
foot concrete weir with a stone chute.
Overall condition of the dam is fair.
Upstream and downstream slopes are covered
with birch trees. There is some concrete
spalling on both sides of the spillway.

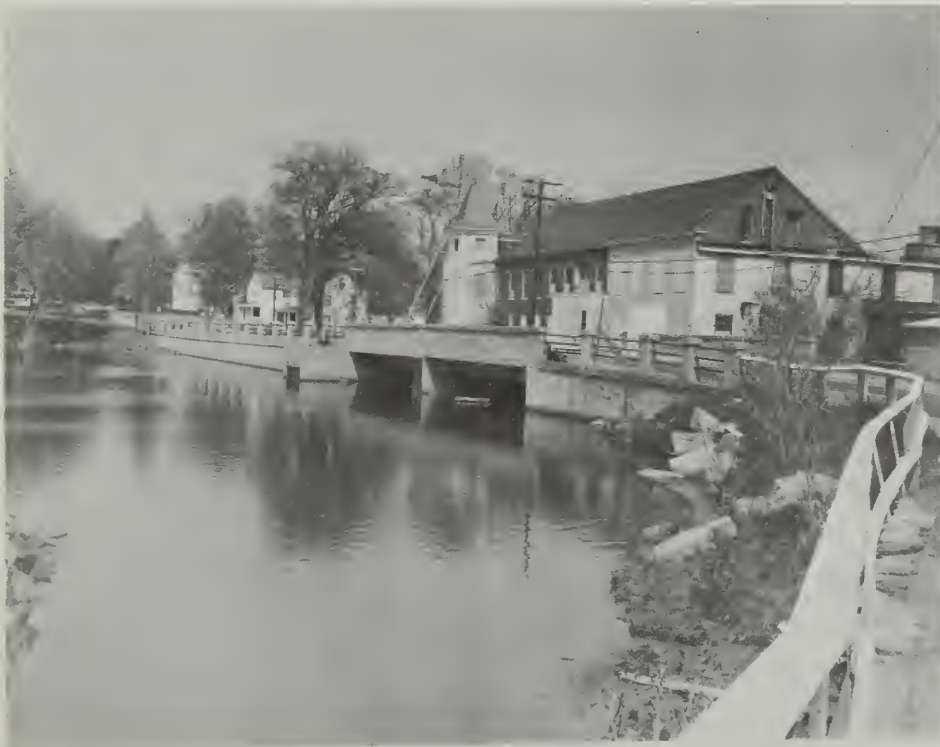
NA-0321 -- OVERLOOK RESERVOIR

Elm Street forms the dam. Spillway is
two 25 foot wide culverts under the road.
All structures are in good condition.

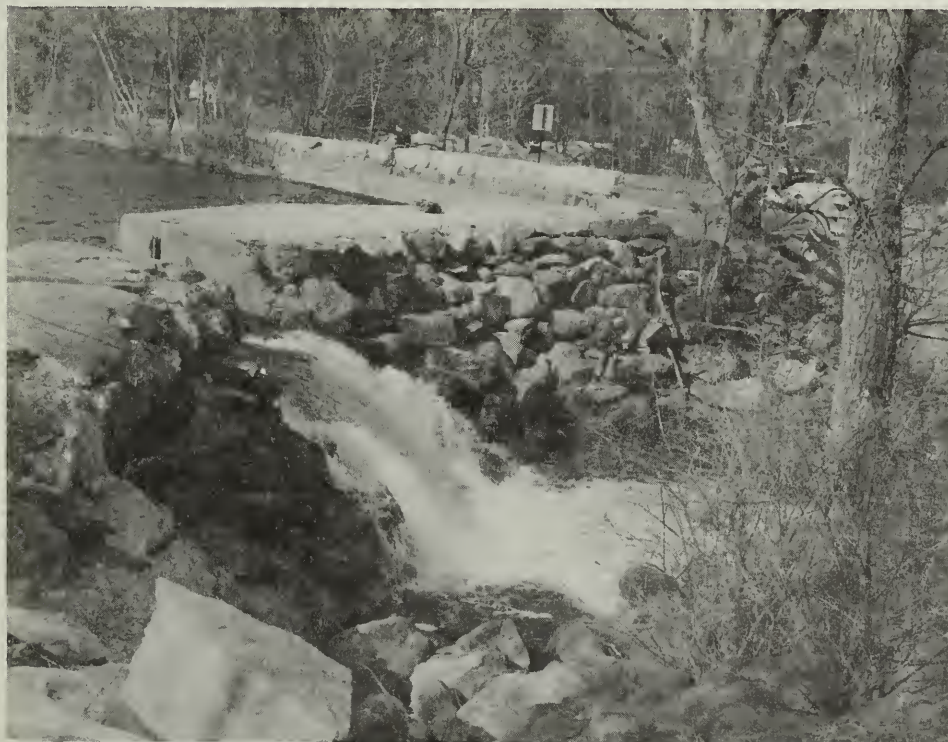
NA-0323 -- MORSE RESERVOIR

Remarks: This is an old stone dam with a concrete
weir type spillway about 8 foot wide.
Condition is poor.

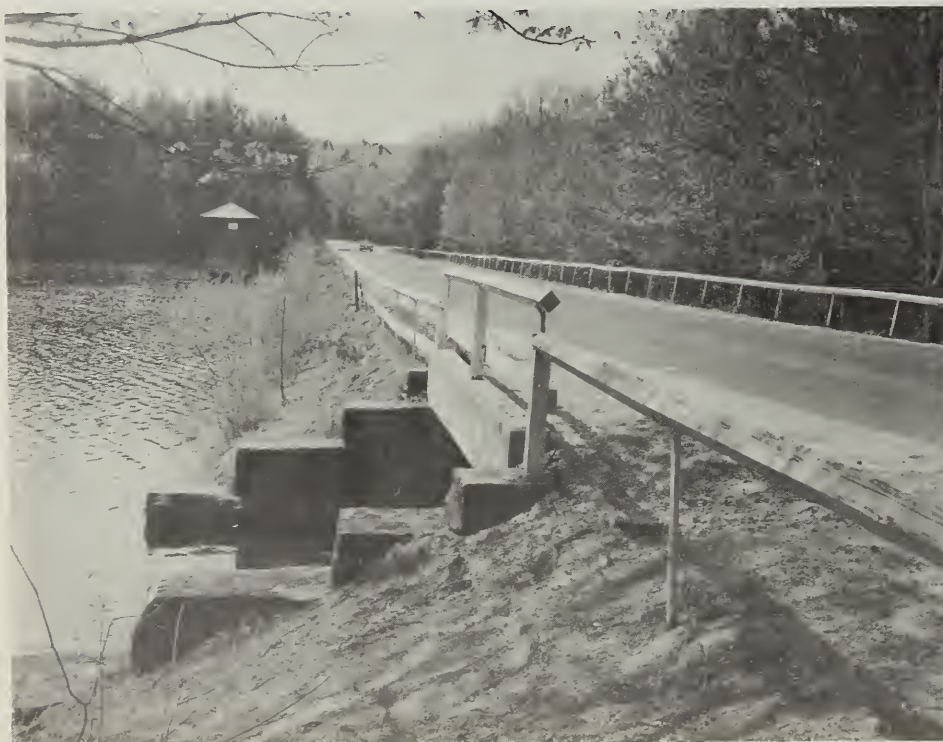
NA-0324 -- LOVELL RESERVOIR

Elm Street forms the dam, the upstream slope is riprapped. There is an open spillway culvert under Elm Street 25 feet wide by 6-inches high. There appears to be some seepage at the downstream slope, but overall condition appears good.

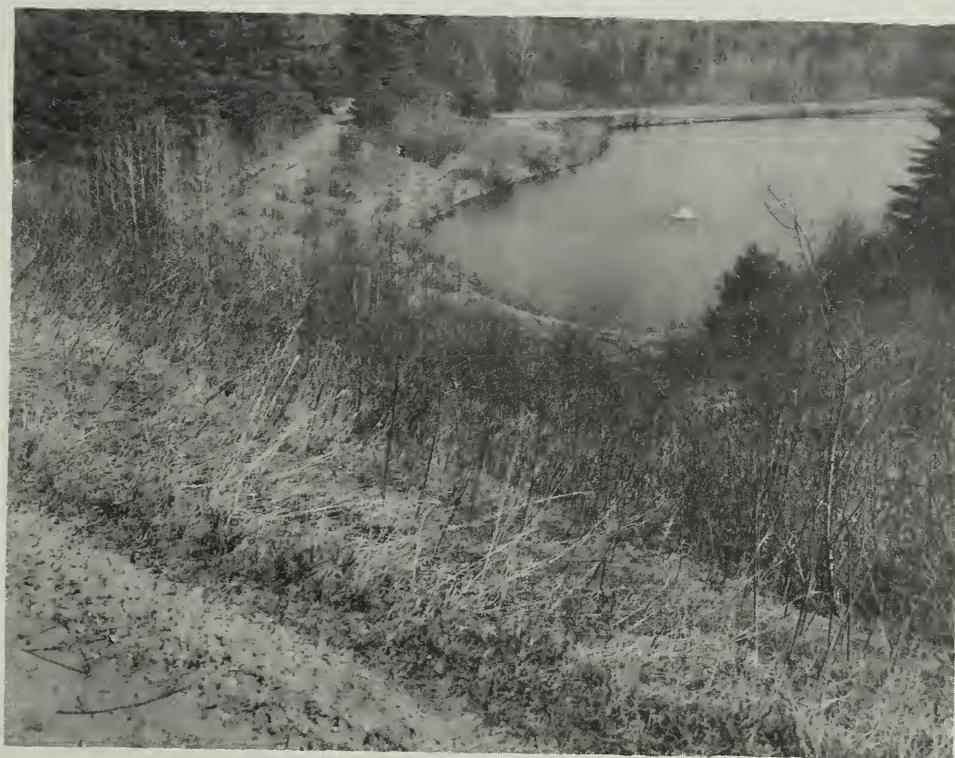
NA-0325 -- SCOTT RESERVOIR

Remarks: This site is part of the Fitchburg Water Supply. The earth dam has a 75 foot wide concrete spillway at the right abutment leading to a paved chute; the dam has a rock paved berm at the 40 foot level on the downstream face. The upstream face is rock riprapped. There is a long dike along the left bank. The dam and spillway are in good condition.

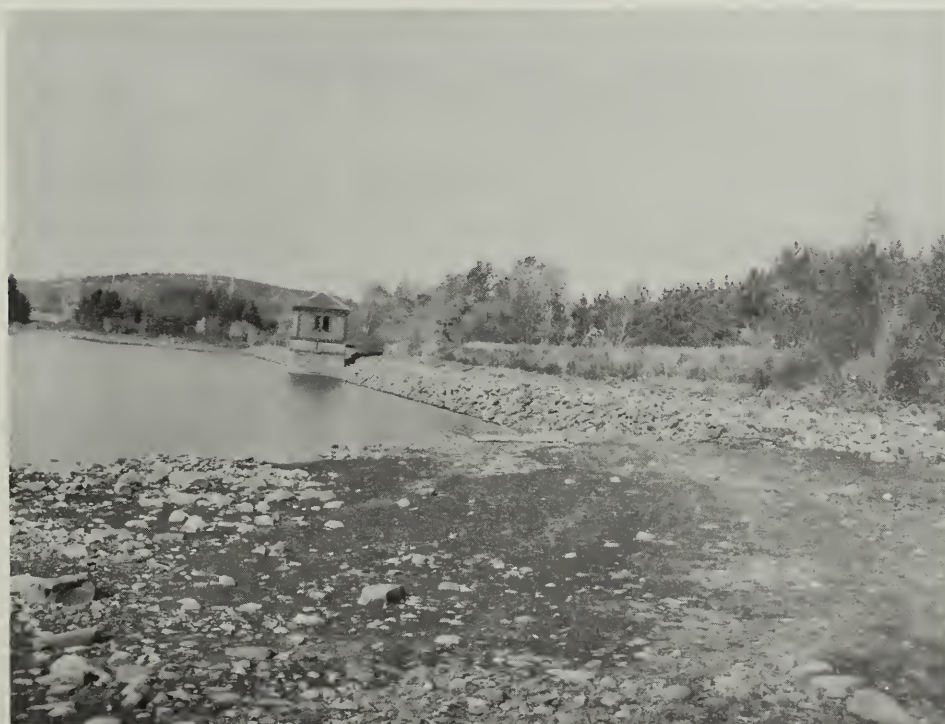
NA-0423 -- LAKE SAMOSET

This is a part of the Leominster Water
Supply. The emergency spillway at the
right abutment is about 25 feet wide and
6 feet deep. Structure is a long earth-
fill dam with riprap on the upstream slope.
The dam has trees and brush growing on
the downstream slope.

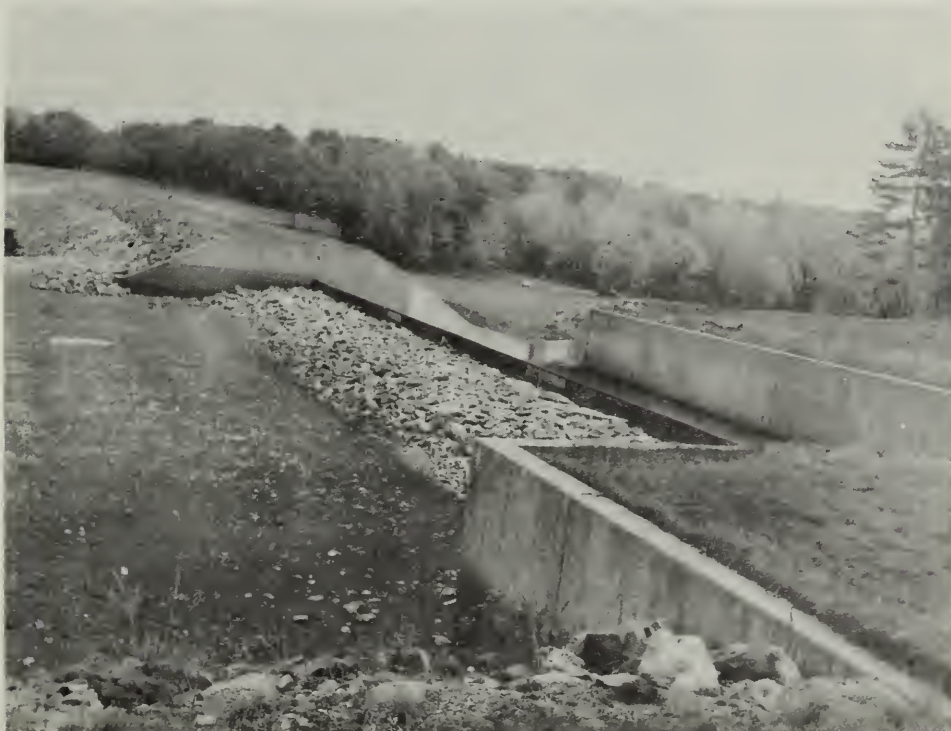
NA-0529 -- ASNEBUMSKIT POND

Remarks: This reservoir is owned by the Bureau of Water, City of Worcester. Structure is an earth dam with a side channel inlet chute spillway on the right abutment. Inlet weir is about 200 feet long. Outlet channel is about 30 feet wide and 8 feet deep. Upstream slope of the dam is rock rip-rapped. Dam and spillway are in very good condition.

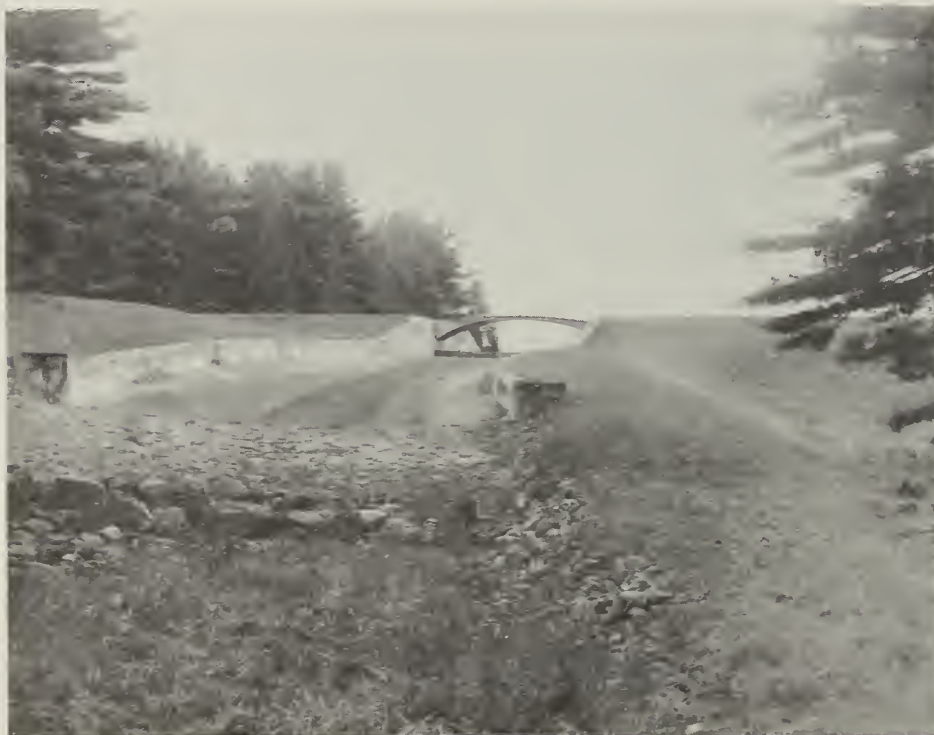
NA-0532 -- STUMP POND

This is a Worcester water supply reservoir. Structure is an earth dam with rip-rapped upstream slope. Spillway is a 30 foot wide concrete chute. Some concrete spalling was noted on the sidewalls. Earth-fill section is well-maintained. This reservoir receives water diverted from Asnebumskit Brook.

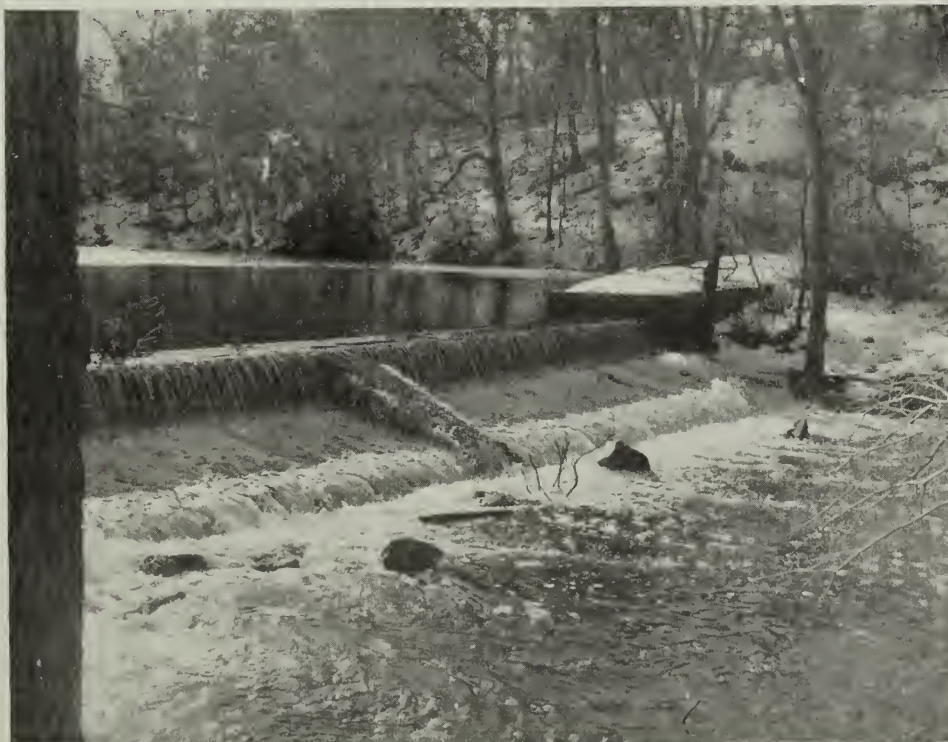
The spillway, a concrete weir about 50
feet long, controls the water level in
Plow Shop Pond and Grove Pond (NA-0723).
Spillway is in fair condition, sidewalls
are cracked.

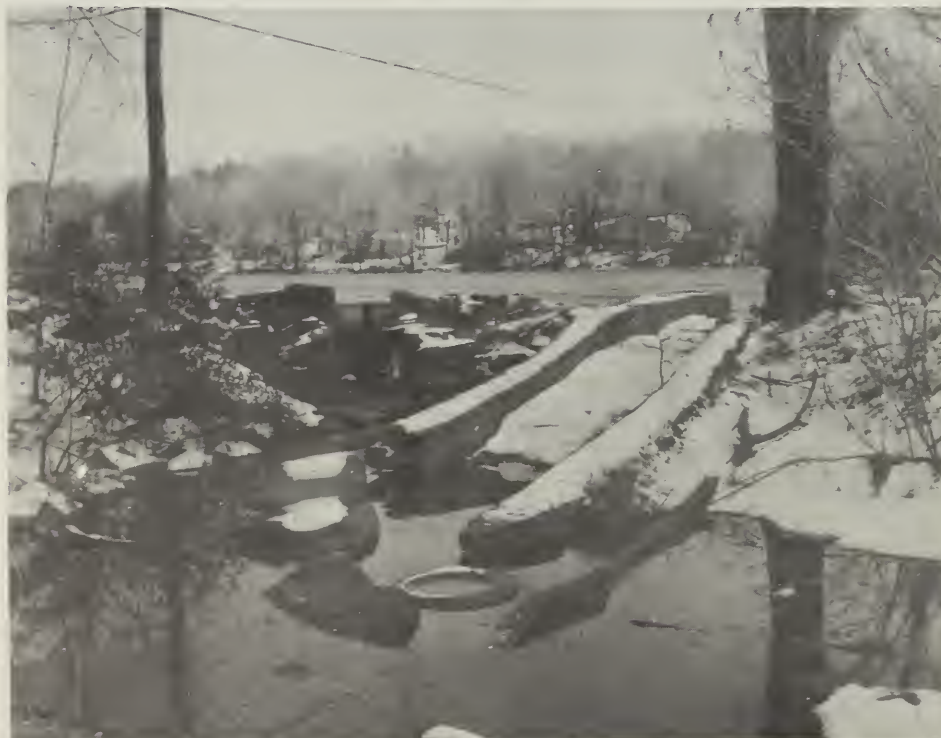
SITE NA-0824 Spectacle Pond

This is a low earth dam with a 3 foot wide
open spillway and an auxiliary chute spill-
way. There are trees growing on the fill
and the concrete spillways are cracked in
many places. Overall condition of the
structure is poor.

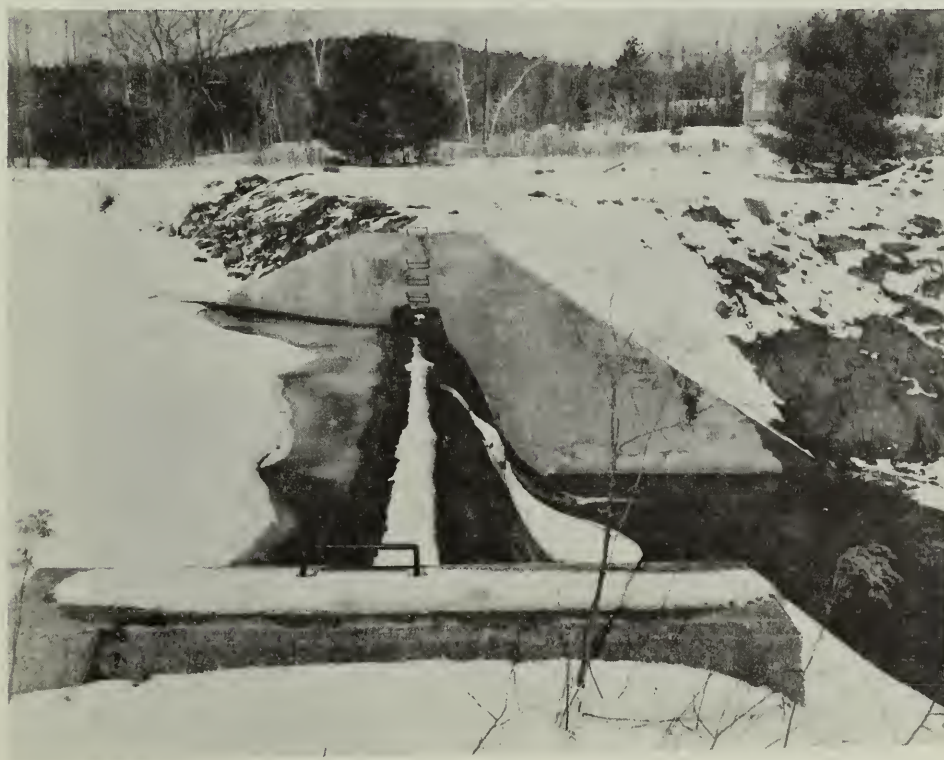
SITE NA-1026 -- HARBOR POND

This is an earth dam with a 70 foot wide
ogee spillway. Upstream slope of the dam
is rip-rapped. Dam and spillway are in
good condition.

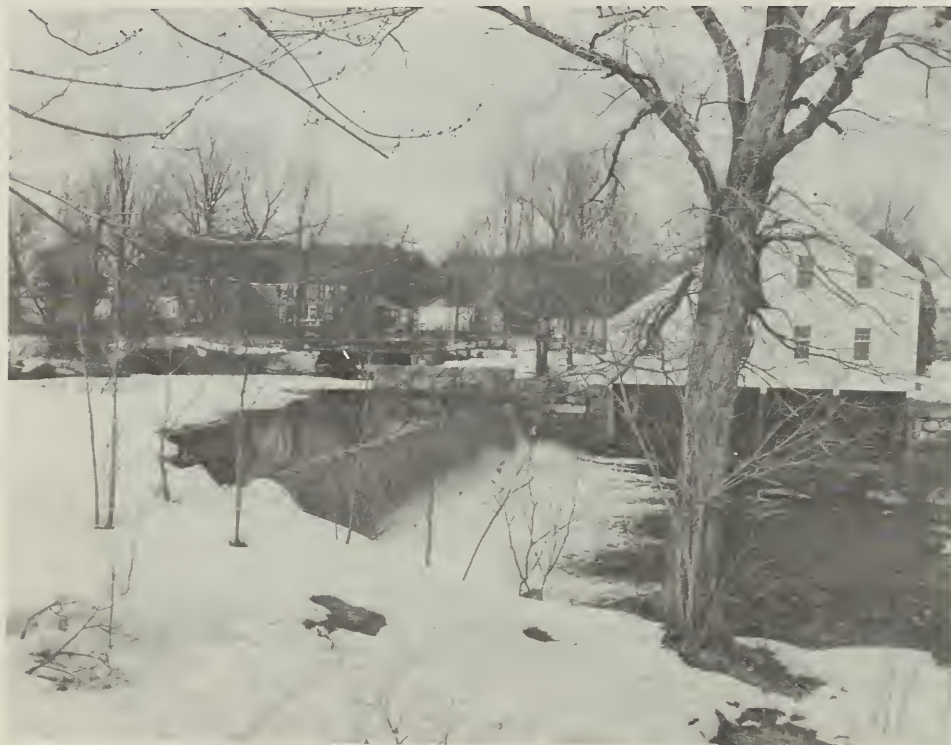
SITE NA-1027 -- GRAVES POND

This is a stone block masonry dam.
The spillway is about 90 feet wide.
Structure is in fair condition.

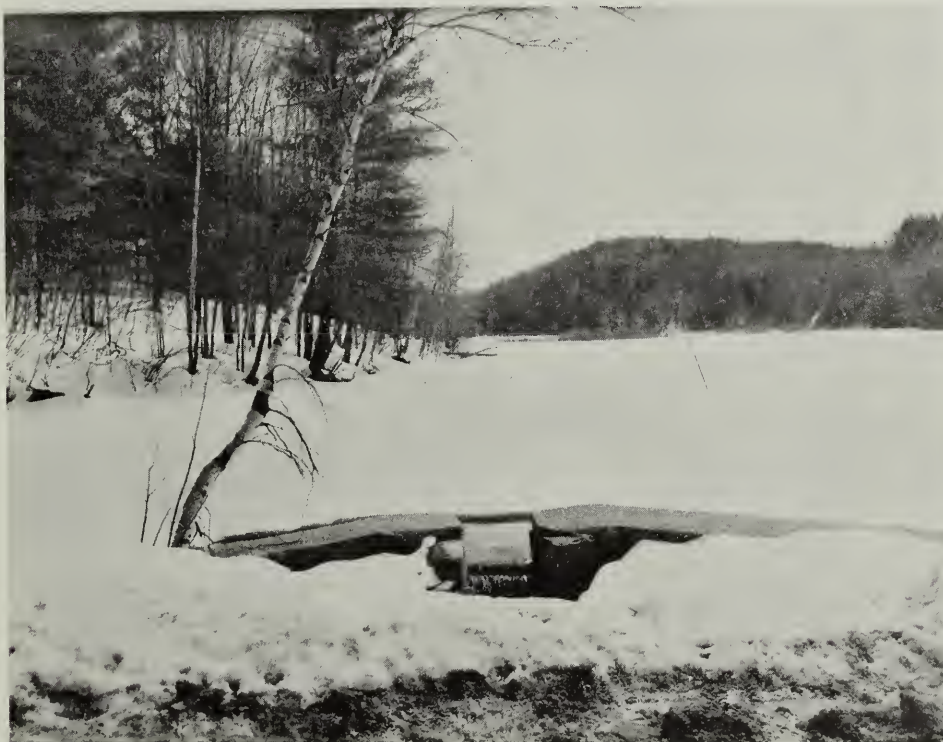
SITE NA-1127 -- COON TREE POND

This is a small concrete and stone structure
at the Heald Street road culvert. Weir
notch is about 18-inches wide and 18-inches
deep. Spillway is in poor condition.
